<b>Analysis Report - 2000-13153</b>			
	<b>Customer Name:</b>	SAMPLE REPORT-15	<b>Purchase Order:</b>	4504435317
	<b>Part Number:</b>	S29GL256S11TFIV10	<b>Lot/Date Code:</b>	1521
	<b>Manufacturer:</b>	SPANSION	<b>Devices Received:</b>	50

## Summary Of Inspection Results

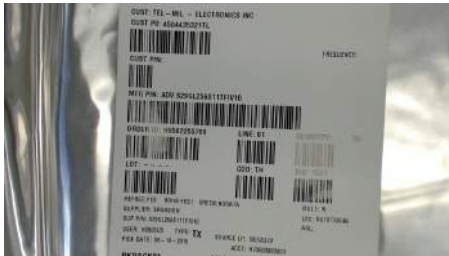
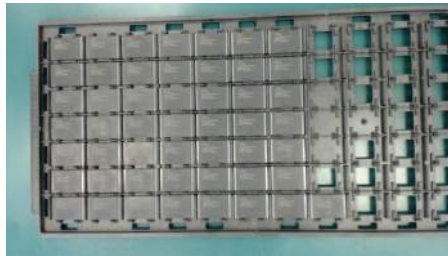
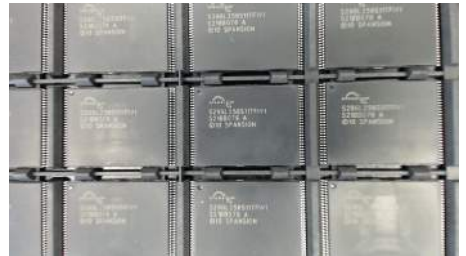
Devices were received in acceptable condition. Total 50 devices, date code 1521.

Figure 1. INCOMING

Figure 2. INCOMING

Figure 3. INCOMING

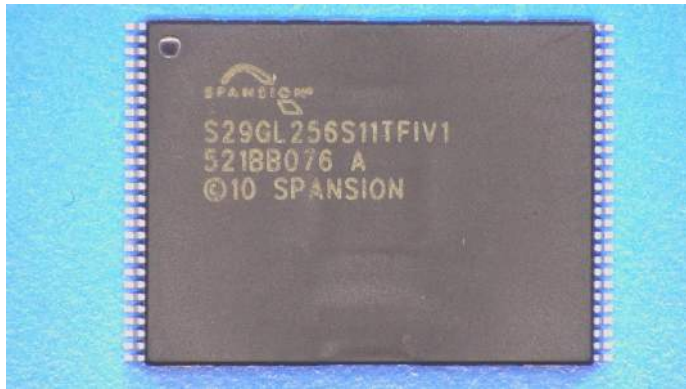
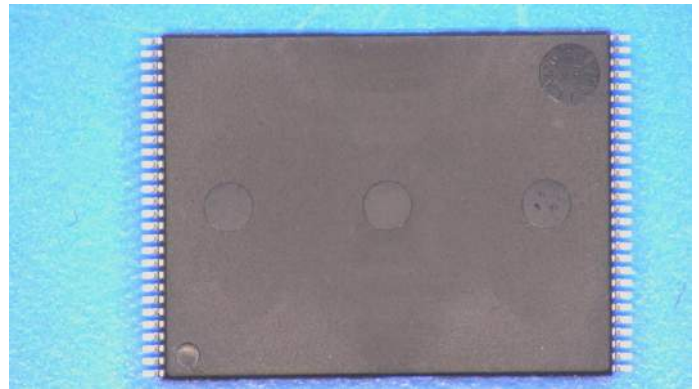
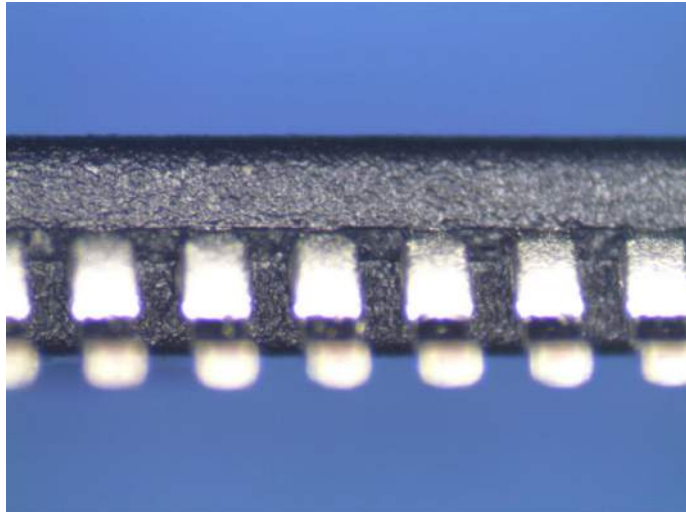
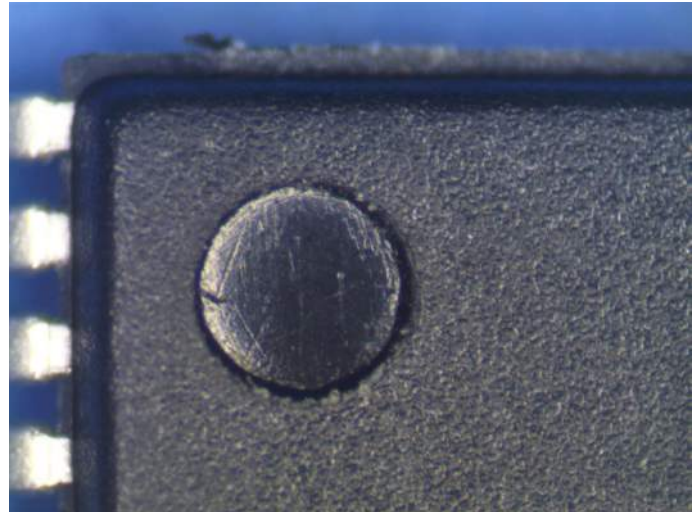
50 devices from date code 1521 were visually inspected. No anomalies were found. Devices passed visual inspection.

**Figure 4. TOP**

**Figure 5. BOTTOM**

**Figure 6. SIDE**

**Figure 7. TOP PIN**

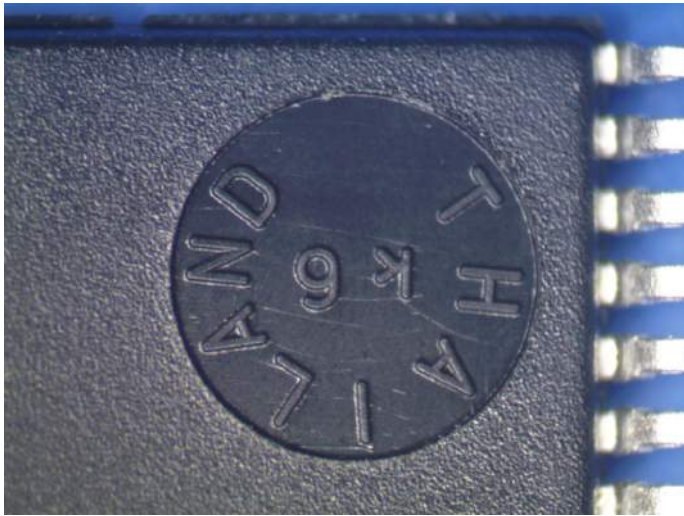
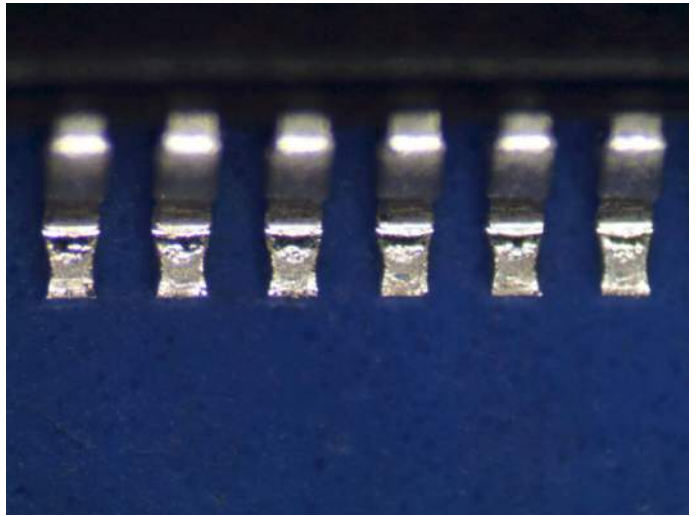
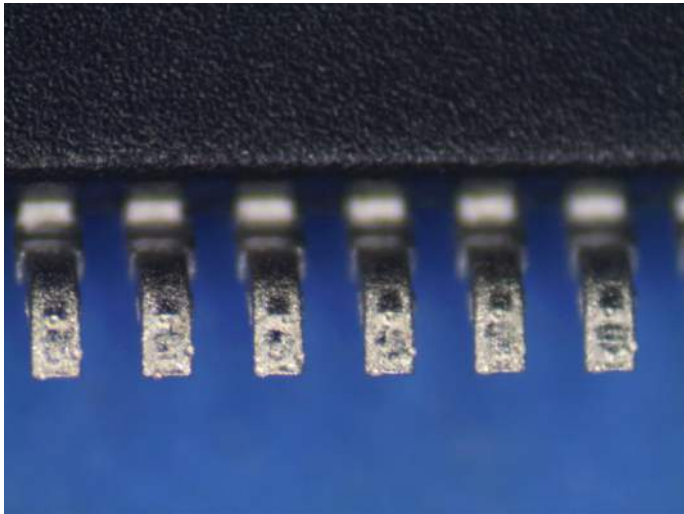
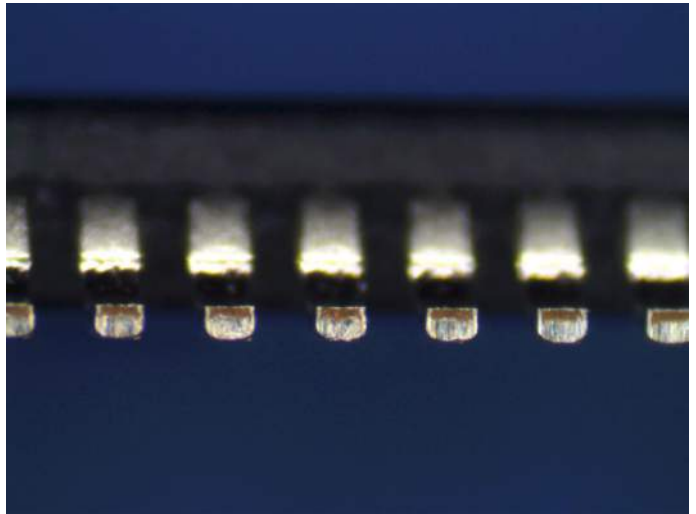
**Figure 8.** BOTTOM PIN

**Figure 9.** LEADS VIEW 1

**Figure 10.** LEADS VIEW 2

**Figure 11.** LEAD ENDS

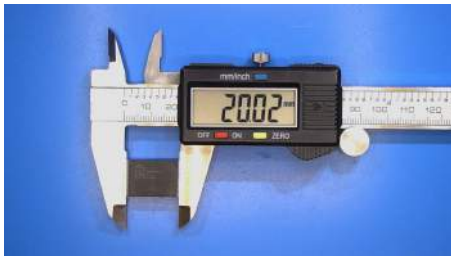
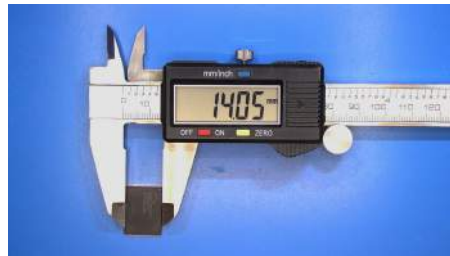
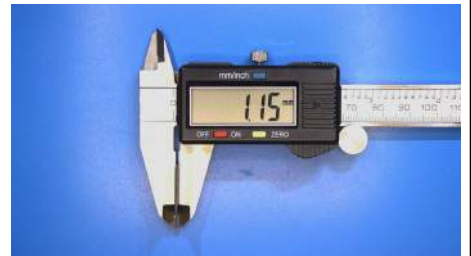
L=20.02mm, W=14.05mm, Thickness=1.15mm

**Figure 12.** LENGTH

**Figure 13.** WIDTH

**Figure 14.** THICKNESS

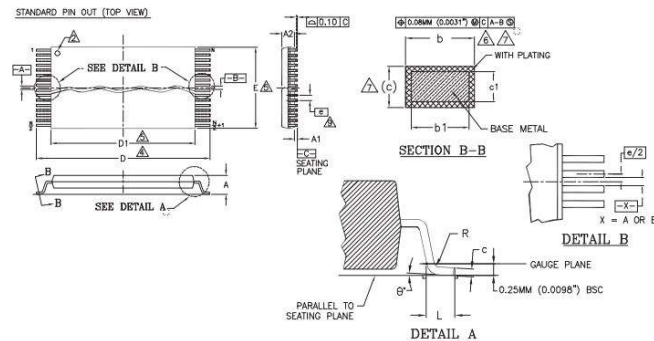
**Figure 15. PHYSICAL DIMENSIONS**

**Figure 11.2 56-Pin Thin Small Outline Package (TSOP), 14 x 20 mm**

PACKAGE	TS 56		
JEDEC	MO-142 (B) EC		
SYMBOL	MIN.	NOM.	MAX.
A	---	---	1.20
A1	0.05	---	0.15
A2	0.95	1.00	1.05
b1	0.17	0.20	0.23
b	0.17	0.22	0.27
c1	0.10	---	0.16
c	0.10	---	0.21
D	19.80	20.00	20.20
D1	18.30	18.40	18.50
E	13.90	14.00	14.10
e	0.50 BASIC		
L	0.50	0.60	0.70
ø	0"	-	8"
R	0.08	---	0.20
N	56

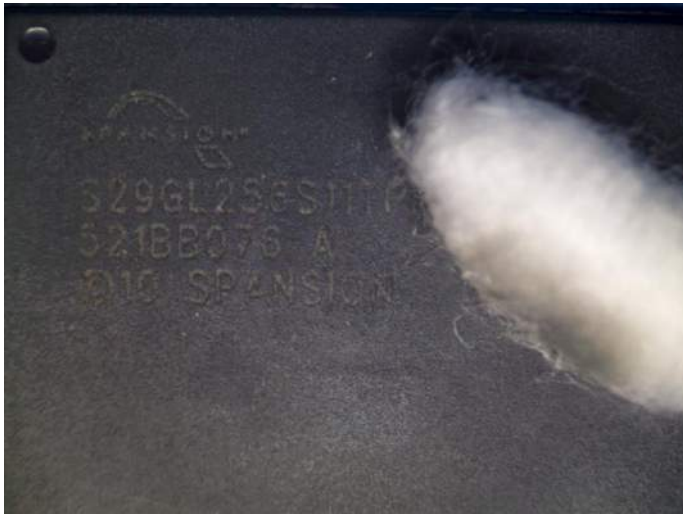
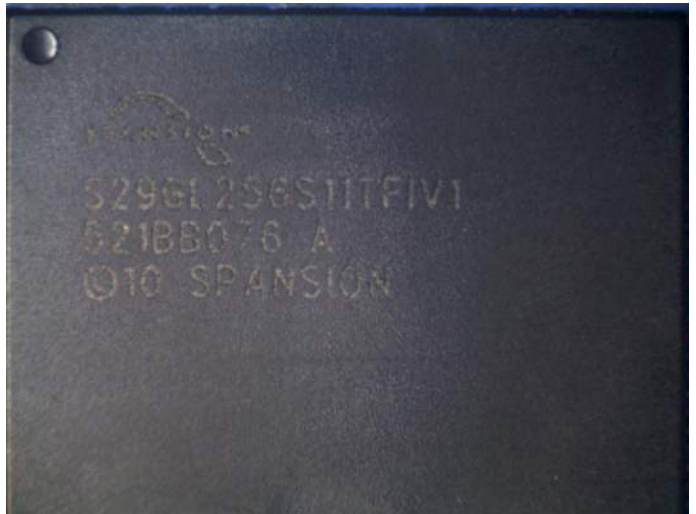
Criteria	Acceptable	Suspect	Not Acceptable	N/A	Comments / Observations
Re-Surfacing / Re-Marking Testing (SAE AS6081)					
Solvent Test for Re-Surfacing - Acetone (Destructive)(CAS Registry 67-64-1)	X				Acetone test was performed on 1 device with date code 1521. No secondary coating was removed during this process. Device passed acetone testing.
Solvent Test for Re-Surfacing - Heat Solvent (Destructive) Dynasolve 750	X				HST (Heated Solvent Test) was performed on 1 device from date code 1521 using Dynasolve 750 solution. No secondary coating was removed during this process. Device passed HST testing.

Figure 16. ACETONE

Figure 17. HST

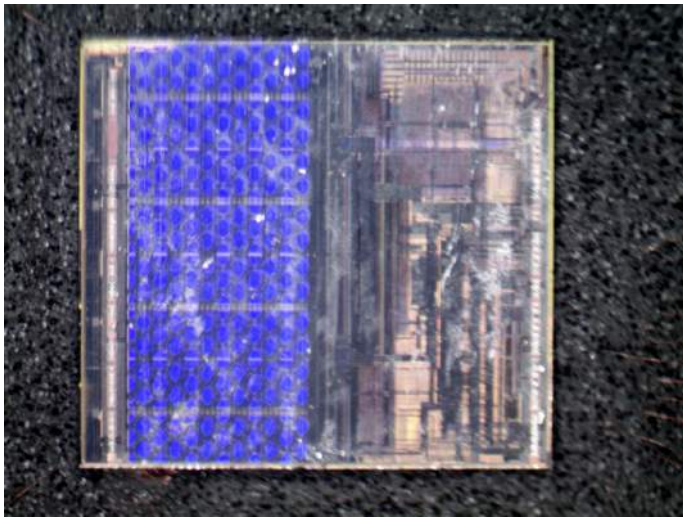
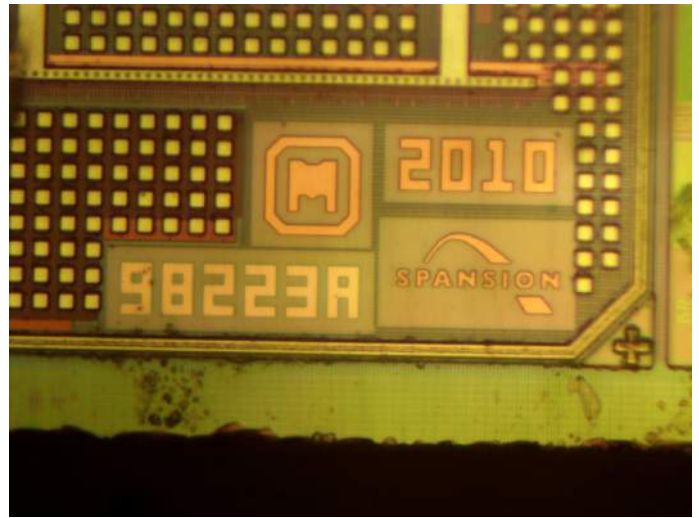
Internal inspection was performed on 1 device with date code 1521. Device revealed Spansion logo with 2010 copyright. Die marking 98223A was also found.

**Figure 18. DIE TOPOGRAPHY**

**Figure 19. DIE MARKING**

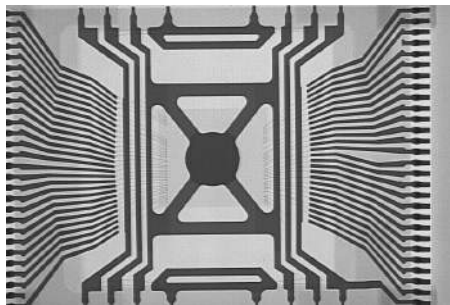
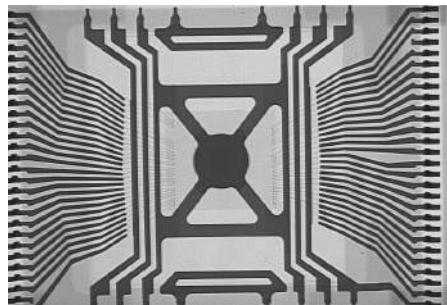
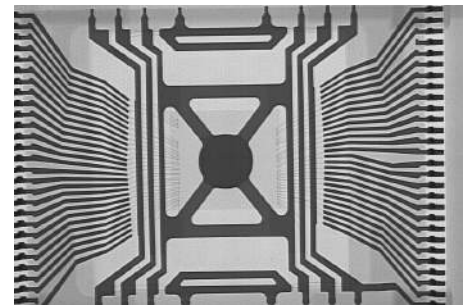
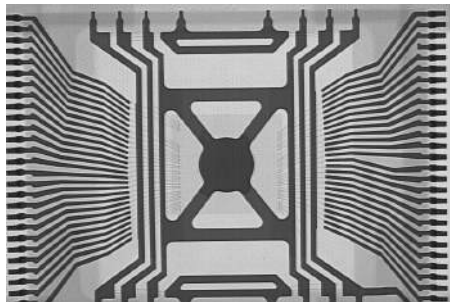
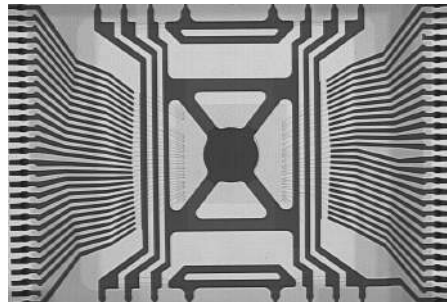
5 samples of date code 1521 were X-ray. Die construction and size are all the same. No anomalies were found.

**Figure 20.**  
SO13153-S29GL256S11TFIV10\_000001\_XRAY

**Figure 21.**  
SO13153-S29GL256S11TFIV10\_000002\_XRAY

**Figure 22.**  
SO13153-S29GL256S11TFIV10\_000003\_XRAY

**Figure 23.**  
SO13153-S29GL256S11TFIV10\_000004\_XRAY

**Figure 24.**  
SO13153-S29GL256S11TFIV10\_000005\_XRAY

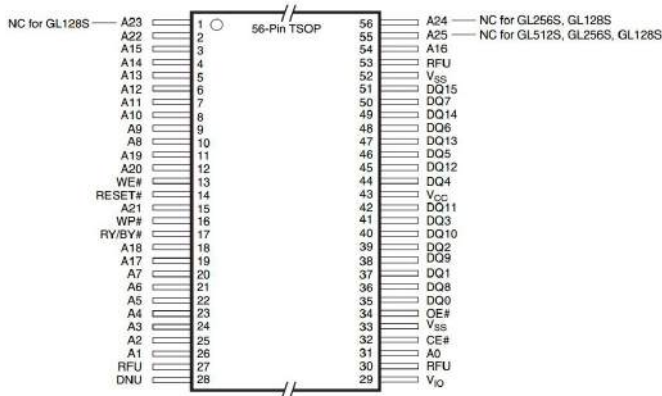
**Figure 26. PIN DIAGRAM**

S29GL256S11TFIV10: NOR Flash Parallel 3V/3.3V 256M-bit 16M x 16 110ns  
 56-Pin  
 TSOP  
 Pin Diagram

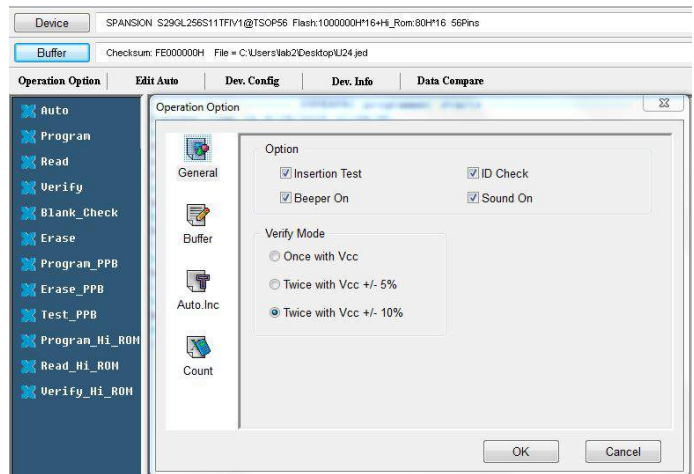
**Figure 27. S29GL256S11TFIV10 CHECK ID**

DUT Test Features are turned on at 25C

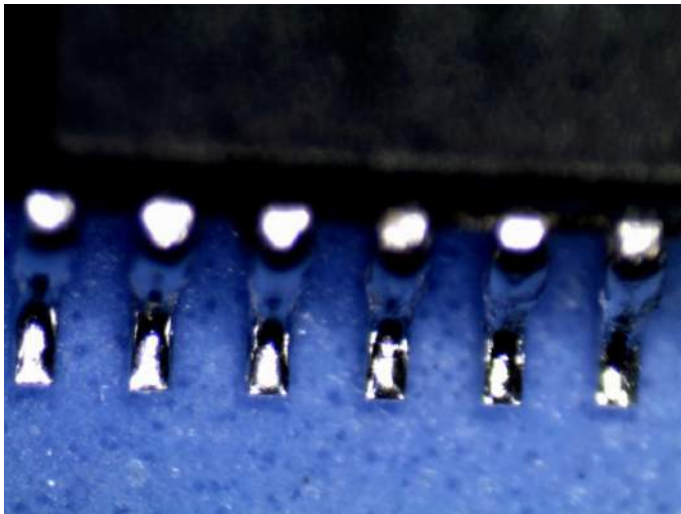
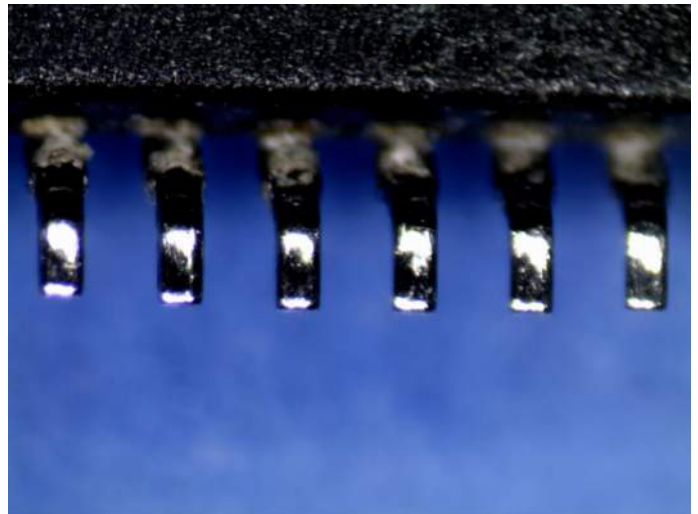
1 device from date code 1521 was tested using dip and look method. Device was inspected under 20X magnification. All leads indicated to have over 95% solder coverage. No pinholes or voids are found.

**Figure 32.** SOLDER LEADS VIEW 1

**Figure 33.** SOLDER LEADS VIEW 2
